CITY OF BAINBRIDGE ISLAND
ENVIRONMENTAL TECHNICAL ADVISORY COMMITTEE (ETAC)

Special Meeting to Address Suzuki Property

Thursday, April 21, 2016

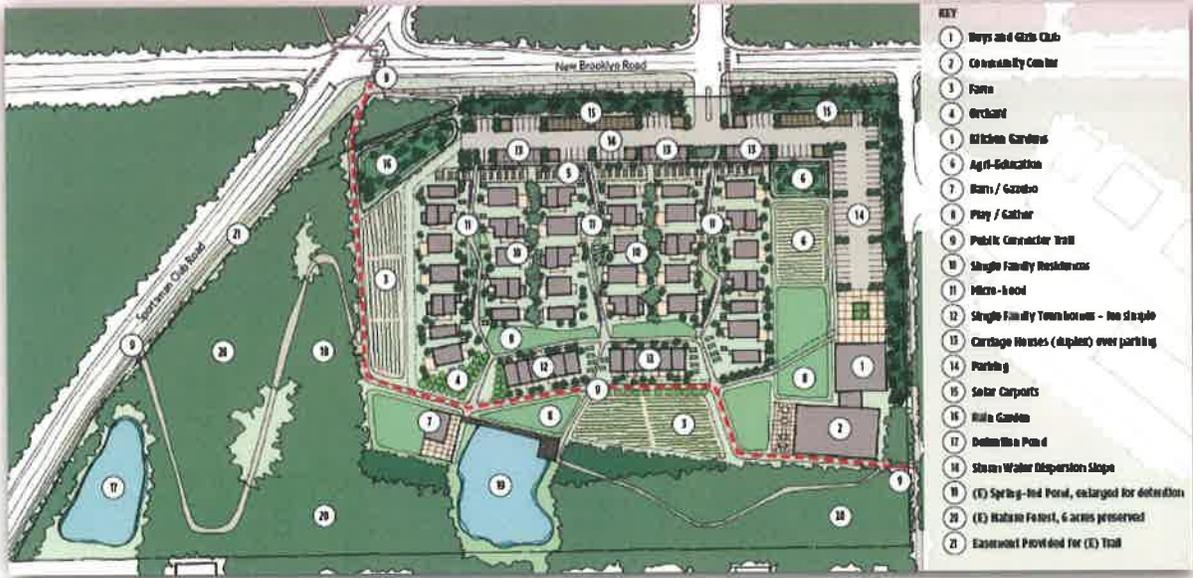
Figure 1 – OPG Development Proposal

The primary purpose of the meeting was to discuss the Suzuki property's significant features and characteristics which will be addressed in an ecological assessment later. The first step, which proceeded, this meeting was for the City to gather together available information from their files. They reported that they have none. As background for the discussion a plan view of the selected development proposal (Figure 1) and a picture of the site presenting the significant features (Figure 2) were available.

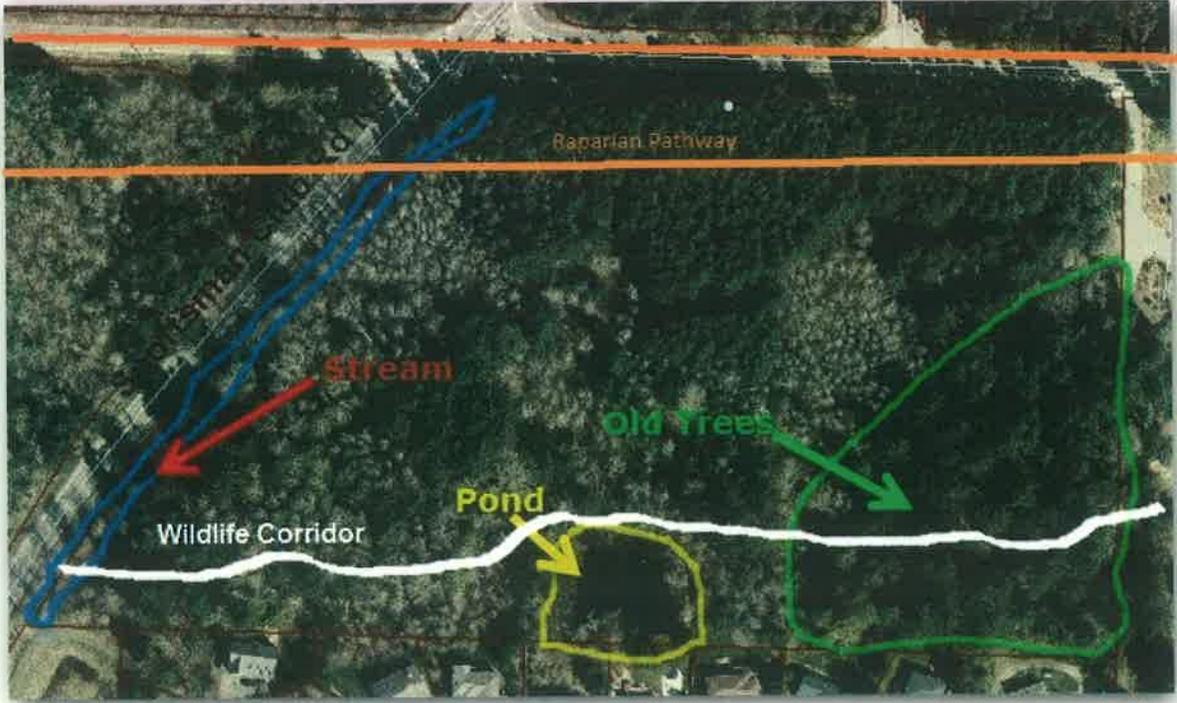
Figure 2: Suzuki Property Overview

- 1) Old Trees – There are 12 trees whose age is estimated to be between approximately 200 and 100 years (see Table I) located in the southeast section of the property.

- 2) Pond – This feature is clearly not a natural feature. It may be as old as 100 - 200 years given the age of one of the trees growing from its constructed containment berm. The fact that the pond is never dry indicates that there is a connection with a near surface aquifer. The depth of the pond has been reported by one of the residents as being approximately 10 feet with a seasonally variation of 3 to 4 feet. Since that amount of water level variation would not be attributable to evapotranspiration, it is reasonable to assume that the pond is drained into the down slope groundwater table. There is no indication that the pond qualifies as a wetland. However, the pond’s aquatic habitat potential should be addressed.

- 3) Stream – Along the western border of the property there is a small stream which has been reported by residents to the head water of a fish bearing stream as shown on a COBI map of fish bearing streams. This should be investigated. The size of the stream channel does not appear to be a viable fish habitat but connection to the lower reaches should be addressed.

The consensus at the meeting was that these trees should be addressed with attention to their: age, number, extent, health, species and the diversity of the understory.

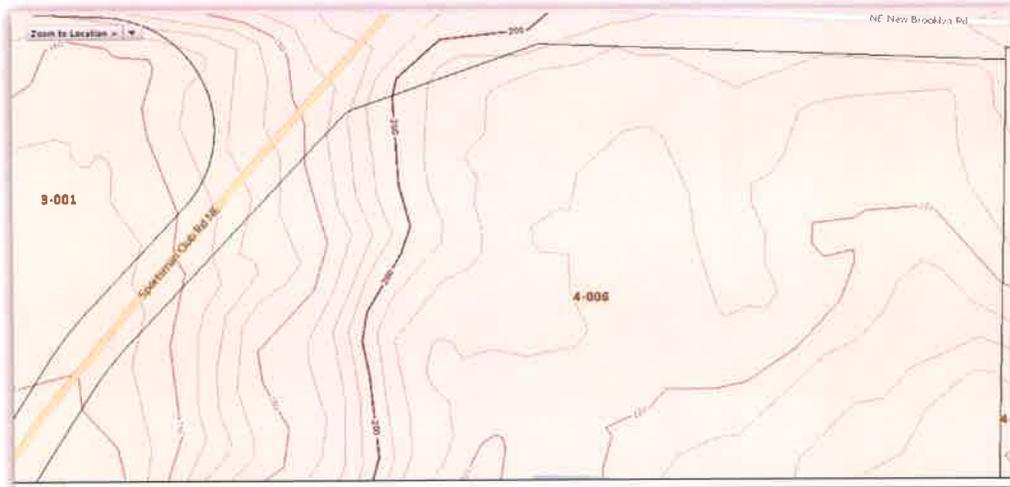
Figure 3 – Topographic view of the Suzuki Property

- 6) Aquifer Recharge Resource – As presented in Figure 3, the property has a gentle slope extending from its eastern border over approximately $\frac{3}{4}$ of the site. The topography then slopes more significantly towards Sportsman Club Road and the southwest corner of the property. The recharge potential of the site should be investigated.
